**Site Inspection Report**

**Cornell Dubilier Superfund Site**

**Inspection Date: September 9, 1999**

**Report Issued: September 30, 1999**

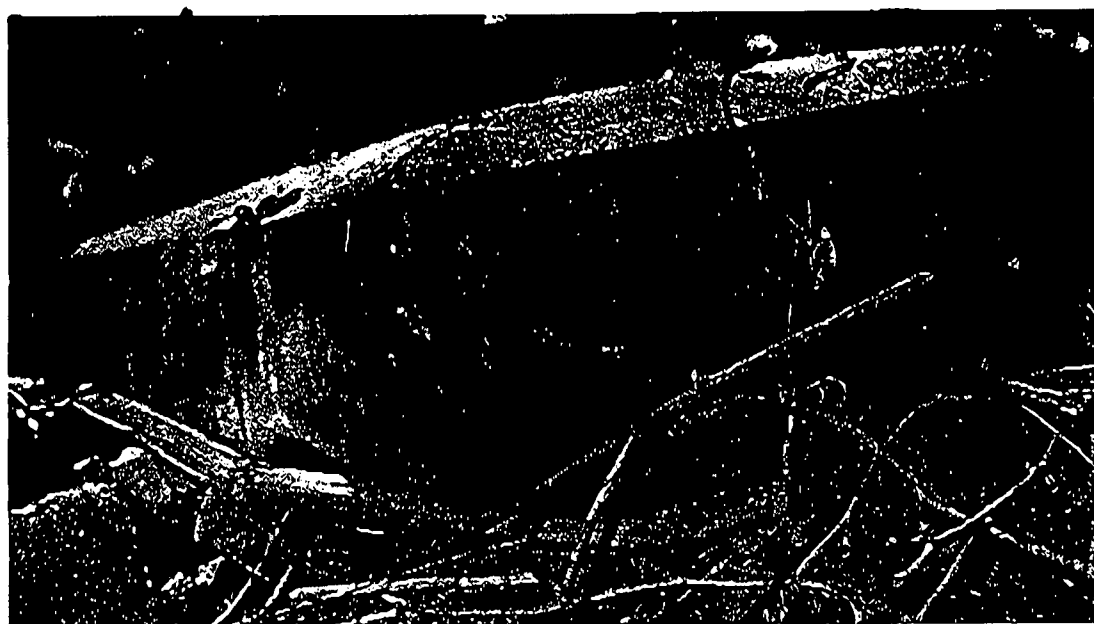
Leaking PCB capacitor  
in the Dismal Swamp,  
South Plainfield, NJ.

3. Designate the Dismal Swamp dumping area containing PCB-contaminated capacitors as an operable unit of the Cornell Dubilier site and immediately delineate the extent of soil, water, and biota impacts of this area (see Attachment A-4).

4. EWA recommends that the EPA investigates the area and conducts a removal action of the capacitors and surrounding soil.
5. Extend the fence line at the site to encompass the entire area along Spice Avenue (beyond the property owner boundary) until such time that EPA can sample the area and prove that contamination stops at the property line.

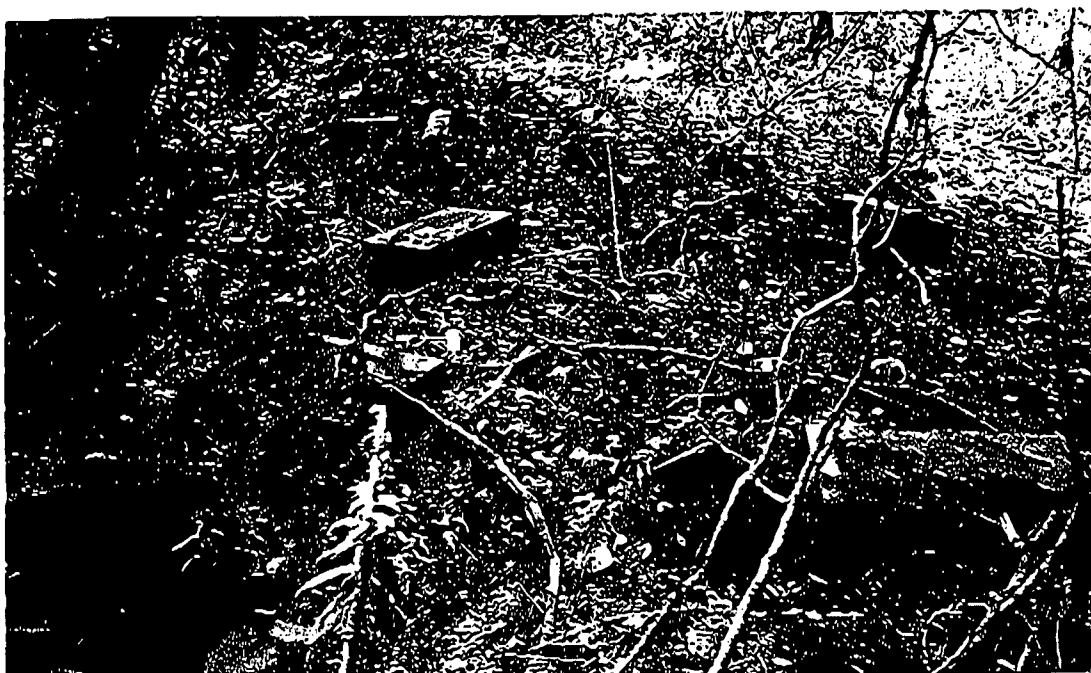
Leaking PCB capacitors  
in the Dismal Swamp,  
South Plainfield, NJ.

We entered the site via a path used for off-road vehicles and began the visual inspection of the site. Haz-mat and DEP personnel counted the suspected capacitors many leaking and various stages decay with visible soil staining around the dump areas. The inspection team determined that at least 22 capacitors are on the surface, the intact units weighing about 30 pounds. Mr. Hoyle took a sample from the contents of one of the capacitors.

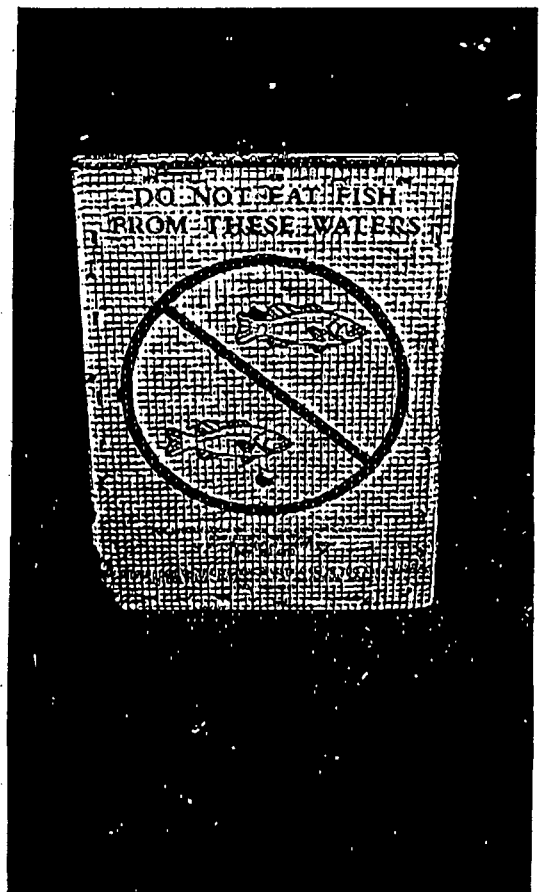
↑ Last remaining advisory sign around New Market Pond. The sign is located in a remote area and does not appear near popular fishing locations.

8. Implement hot-spot removal for PCB's in the Bound Brook above 25 PPM.
9. Install additional signs in the New Market Pond so that subsistence fisherman will be aware of contamination in the fish and pond.
